POWERING A LOCAL UNIVERSITY

CLIENT
LOCAL UNIVERSITY

EQUIPMENT
**1300KVA LOW VOLTAGE
[400/230V] ALTERNATOR**

INCOMING INSPECTION PHOTOS

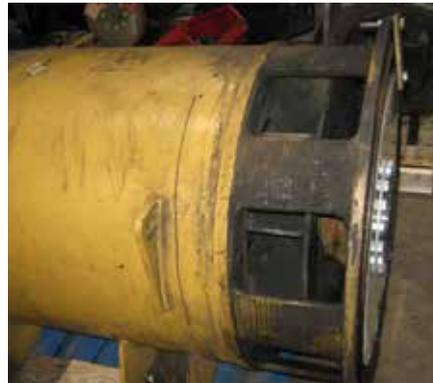
Internal inspection of the alternator showed high levels of dirt build-up inside the terminal box arrangement on the outer casing of the frame and the terminal rails (**Fig 1**). There was also heavy carbon dust covering the main stator and main rotor windings (**Fig 2** and **Fig 3**).
