## REWORKING FOR MARINE VESSELS

CLIENT  
**UK VESSEL OWNER**

EQUIPMENT  
**LOW VOLTAGE [400/230V]  
ALTERNATOR**

APPLICATION  
**MARINE - POWER GENERATION**

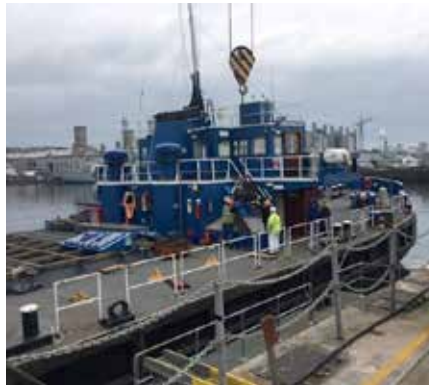
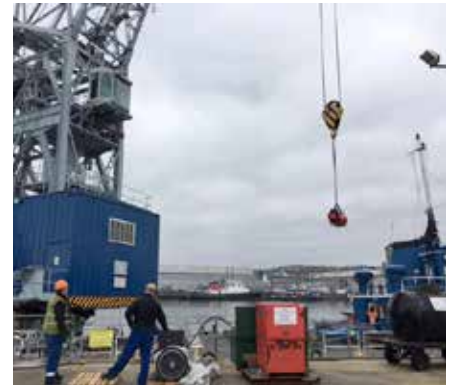
It was reported that the alternator was not producing full voltage and that the winding insulation levels were low.

A site (onboard) inspection by our engineer identified that the alternator had suffered an insulation failure of the main stator, caused by a coolant hose failure on engine, spraying coolant on to the windings.

On this occasion, the customer decided to replace the complete unit which was located in the hull of their vessel.

Our engineers completed the removal of the failed unit and the refitting of the new machine – this involved modifying the mounting arrangements due to difference in the form and fit of the new unit. After re-commissioning, the vessel's power was fully restored.
